Background

Type-57LIS Butterfly Valve

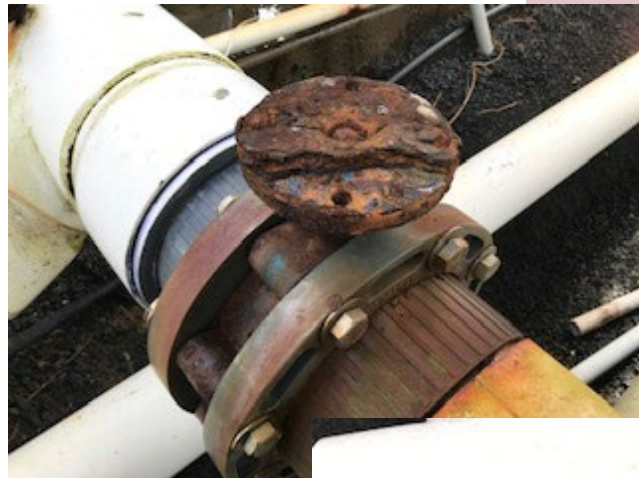
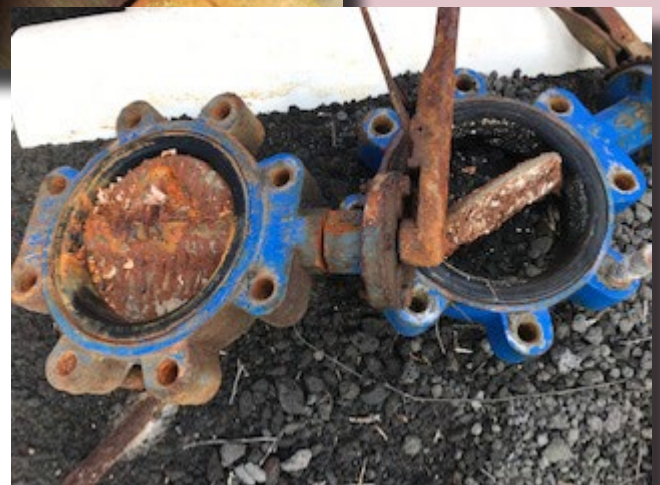
While abalone may thrive in saltwater, it's a harsh environment for metallic valves. A western US aquaculture farm was experiencing widespread issues in their pipelines due to corrosion. The metallic butterfly valves were seizing; their stems shearing; and handles and discs breaking. Rust particles were traveling in the pipelines, constantly causing contamination and blockages in the saltwater feed lines.

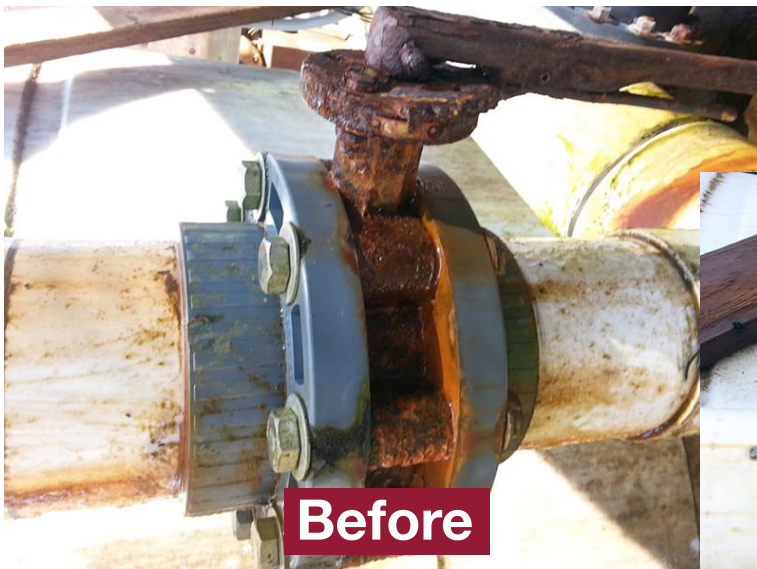
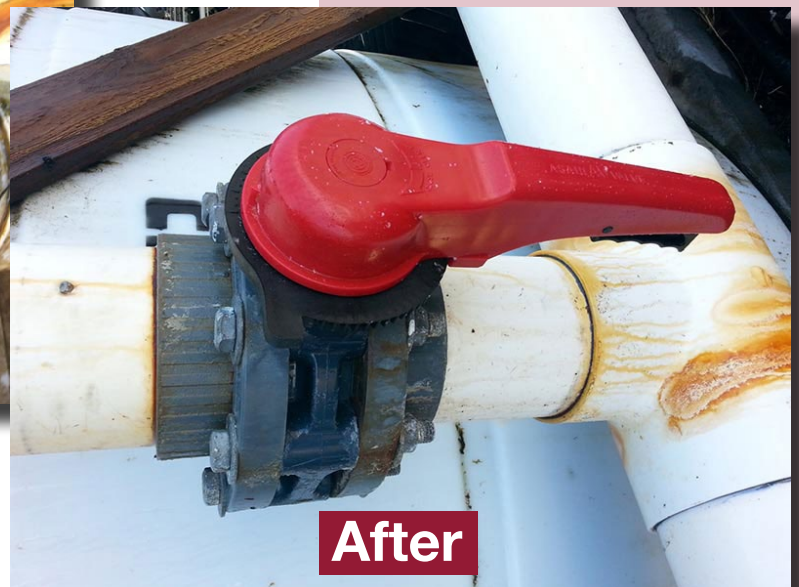
With the results they experienced during the test period, the abalone farm purchased nearly 70 6" and 8" Type-57LIS butterfly valves to replace all of the corroded metallic butterfly valves throughout the farm.

The farm has since retrofitted nearly a third of the Asahi butterfly valves with pneumatic actuators to ease operation at the facility, which will aid in their efforts to upgrade and expand production for their worldwide customer base.

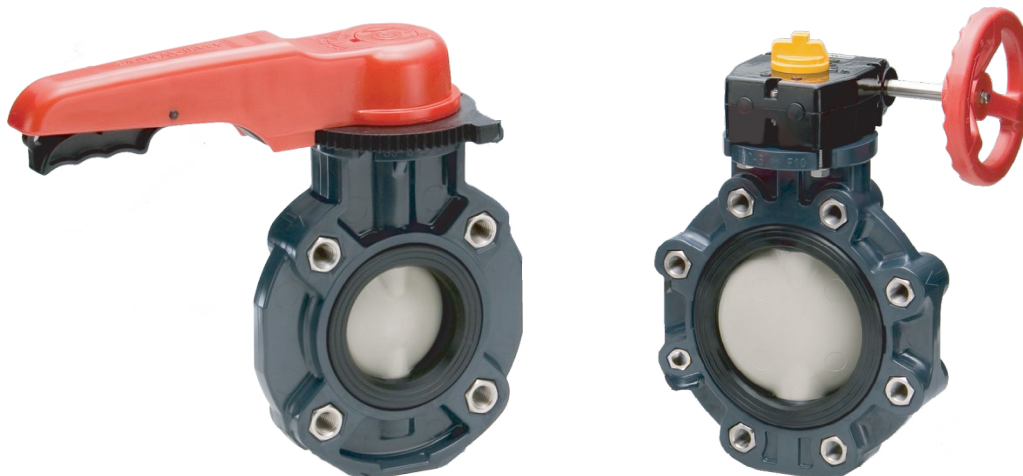
- Direct replacement for metal valves conforming to ISO 5752 short face-to-face dimensions
- Standard model has PVC body with PP disc for superior chemical and corrosion resistance as well as elevated temperature capabilities
- Non-wetted 316 stainless steel stem has full engagement over the entire length of the disc and is totally isolated from the media
- Can be pneumatically or electrically actuated

The Type-57LIS butterfly valve is well suited for a wide variety of life support applications. The Type-57LIS butterfly valve conforms to ISO-5752 short pattern face-to-face dimensions. This allows the Type-57LIS to directly replace metal valves conforming to the same standard. Available in ANSI B16.5 wafer or ANSI lug models with 316 stainless steel drop-in lug inserts. The Type-57LIS butterfly valve can be pneumatically or electrically actuated.
